# Manhole Inspection Summary

Manhole # S29K\_\_021MH

Insp Date: **4/9/09 12:40 PM**

**Location** Address: **720 PORTLAND ST**

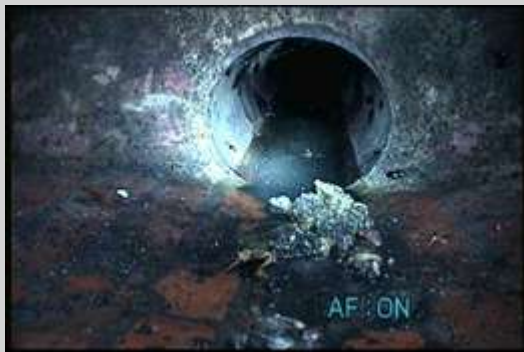
12 O'Clock Outflow

8 in. Circular Gravity Sewer  
Pipe Out @ 12 O'Clock

Pipe Height: **8.4** (in.) Rod and Bar (Angled)

Pipe Material: **Clay** ☐ Pipe Lined

Infiltration: **None** Pipe Seal Cond: **Sound**
